ELECTROSTATIC PRECIPITATOR PERFORMANCE IN OLD BOILERS IN INDIA – CAUSE & SUGGESTED REMEDIAL MEASURES

V.Hariharan
ESP Consultant

K.Sivaraman
Boiler Consultant

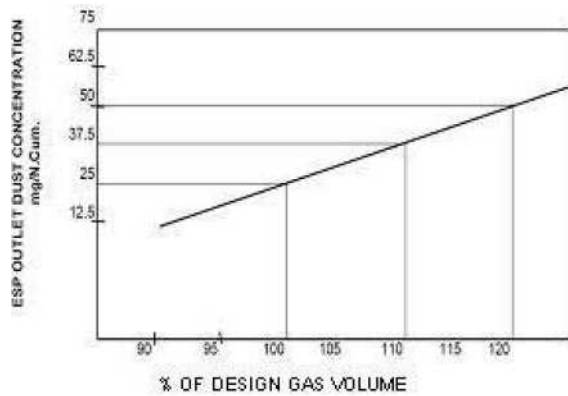
An ESP will operate best when the gas volume keeps the velocity in each and every ESP domain within a typical range of 0.9 to 1.2 meters per second (M/Sec). ESP Designers usually work on an average value for gas velocity from the given gas flow data and derive the needed cross section of the precipitator, taking care of the localized variances with-in any given gas flow pass. However, bulk flow variation / velocity variation between the various passes of the precipitator is generally not addressed - either by the ESP designer or by the boiler designer. The essence of the average gas velocity concept is to optimize the treatment time and to reduce the particulate escape through re-entrainment, while rapping. These losses (particulate escape) tend to increase rapidly above certain critical limiting velocity because of the drag forces on the particles. This critical velocity is a function of gas volumetric flow rate & its density, collecting plate geometry, precipitator size, and other dust particle related factors, such as particle size, dust resistivity, etc. Figure 1 illustrates the effect of higher-than-optimum gas volume, using an outlet loading of 25 mg / normal cubic meter (N.Cu.M) as the base point. A gas volume flow of 10.0 % over design increases the outlet loading by 50 percent, to 37.5 mg / N.Cu.M. Similarly a gas volume flow of 20.0 % over the design increases the outlet dust loading by 120 percent, to a value of 55mg / N.Cu.M. Hence, it becomes essential to design any new / retrofit ESP, for the worst gas flow condition that can be expected / fore-seen

Fig 1 : Effect of ESP Flow Rate Variation on ESP outlet Dust (SPM) Emission
